Inspection Report

Property Address:
1223 Happy Valley Trail
Anywhere, WI 53562

Date: 1/29/2007	Time: 8:09 AM	Report ID: 200701015
Property: 1223 Happy Valley Trail Anywhere, WI 53562	Customer: John Smith Jane Smith	Real Estate Professional: Jane Realtor Wisconsin Realtors Association

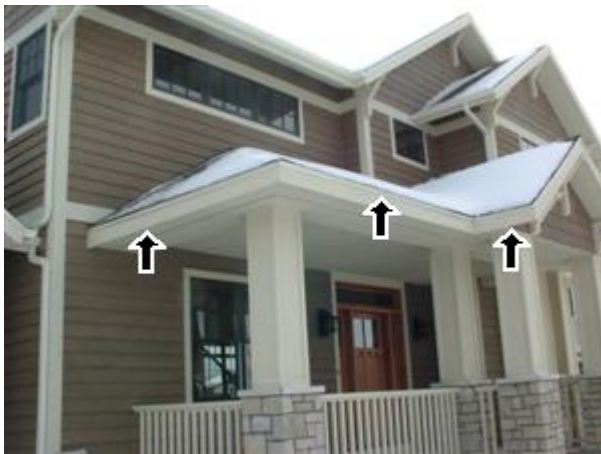
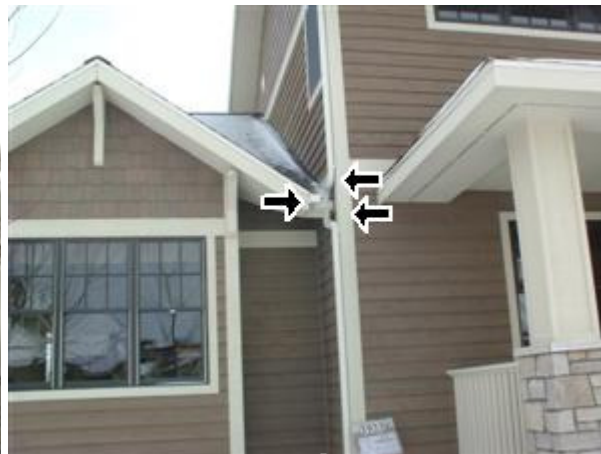
- 1.0 Not inspected due to snow cover at time of inspection. We can inspect in the spring at clients request.
- 1.1 Soffit and ridge vent noted. Appears adequate.
- 1.2 Not inspected due to snow cover at time of inspection. We can inspect in the spring at clients request.
- 1.3 None present.
- 1.4 Not inspected due to snow cover at time of inspection. We can inspect in the spring at clients request.
- 1.5 Majority of gutters appear satisfactory, however made note of area at front that slopes toward home. Due to steep pitch gutters may be too small for roof area. Recommend monitor and replace if necessary. No gutters or downspouts noted at front covered porch area. Add as required.

Majority of gutters appear satisfactory, however made note of area at front that slopes toward home. Due to steep pitch gutters may be too small for roof area. Recommend monitor and replace if necessary. No gutters or downspouts noted at front covered porch area. Add as required.

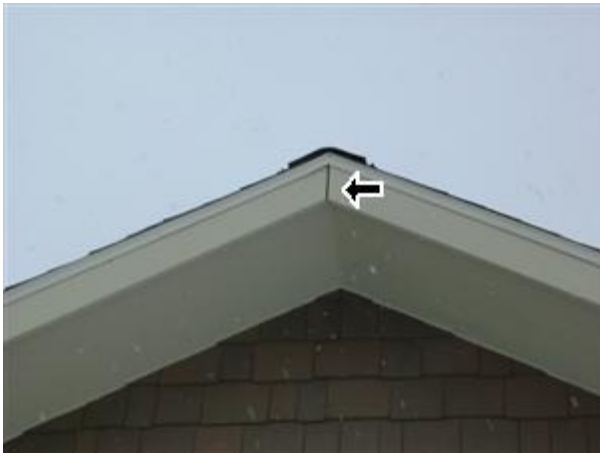
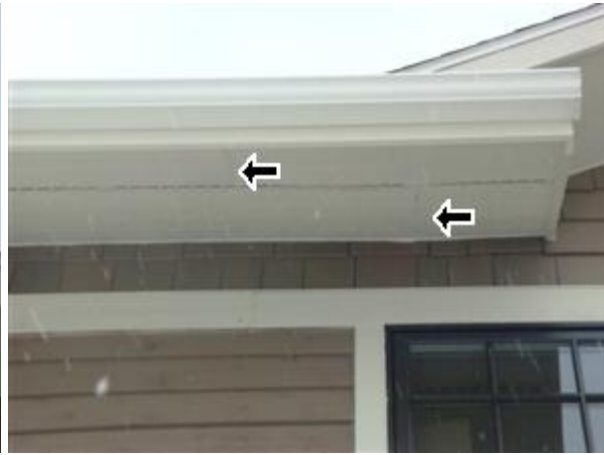
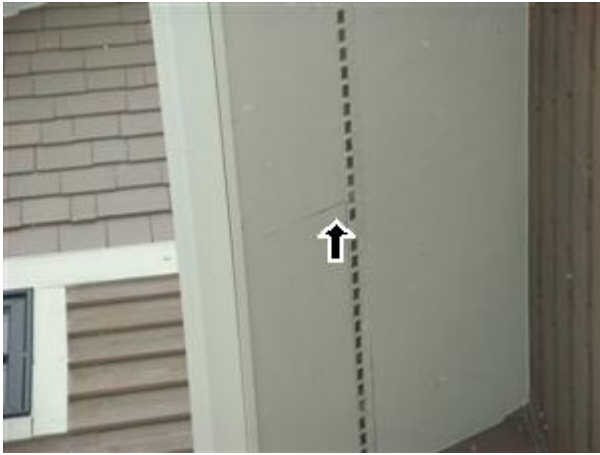
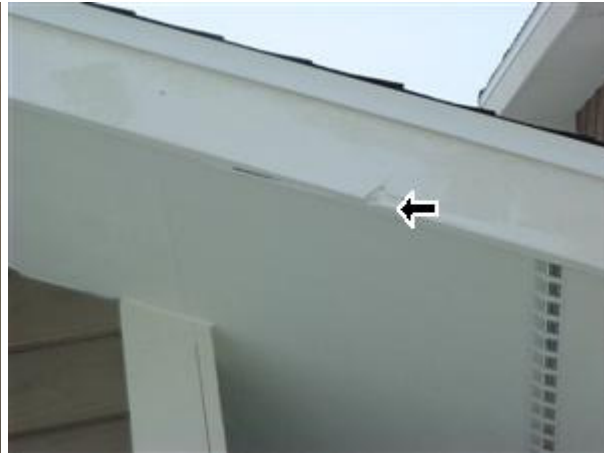
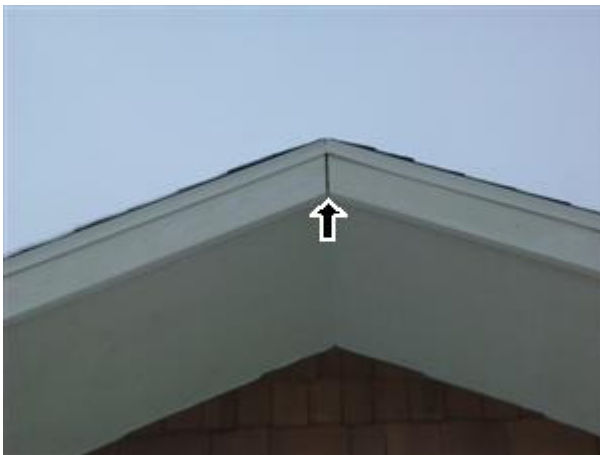
2.0 Majority is satisfactory, however made note of several areas of exposed sagging seams of soffit material and areas of damaged fascia board. Also made note of two areas of fascia boards at peak that have large gaps. Recommend repair or replace as required/desired to avoid premature failure or water penetration.

Majority is satisfactory, however made note of several areas of exposed sagging seams of soffit material and areas of damaged fascia board. Also made note of two areas of fascia boards at peak that have large gaps. Recommend repair or replace as required/desired to avoid premature failure or water penetration.

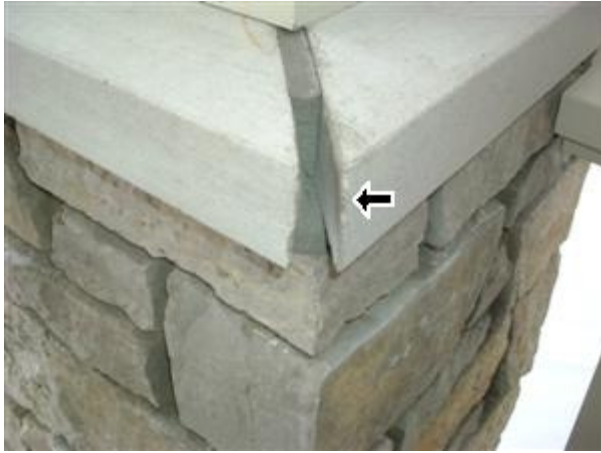
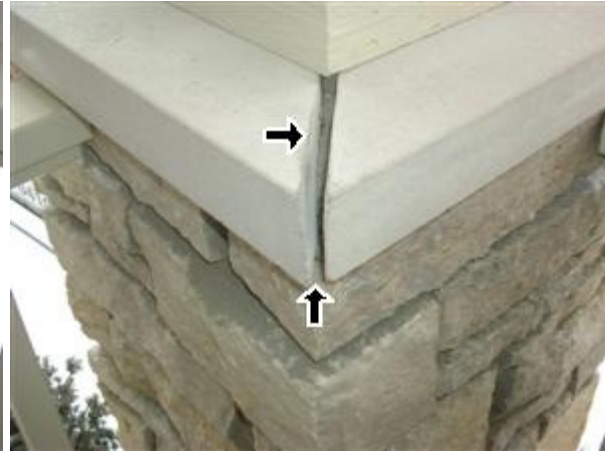
2.4 Elevated wood deck/patio at rear in satisfactory condition at time of inspection. Seal as desired. Made note of missing mortar in concrete caps for front porch pillars. Repair as required.

Elevated wood deck/patio at rear in satisfactory condition at time of inspection. Seal as desired. Made note of missing mortar in concrete caps for front porch pillars. Repair as required.
